NASA TM X-64754

VAMISTOR RESISTOR INVESTIGATION

Quality and Reliability Assurance Laboratory

May 1, 1973

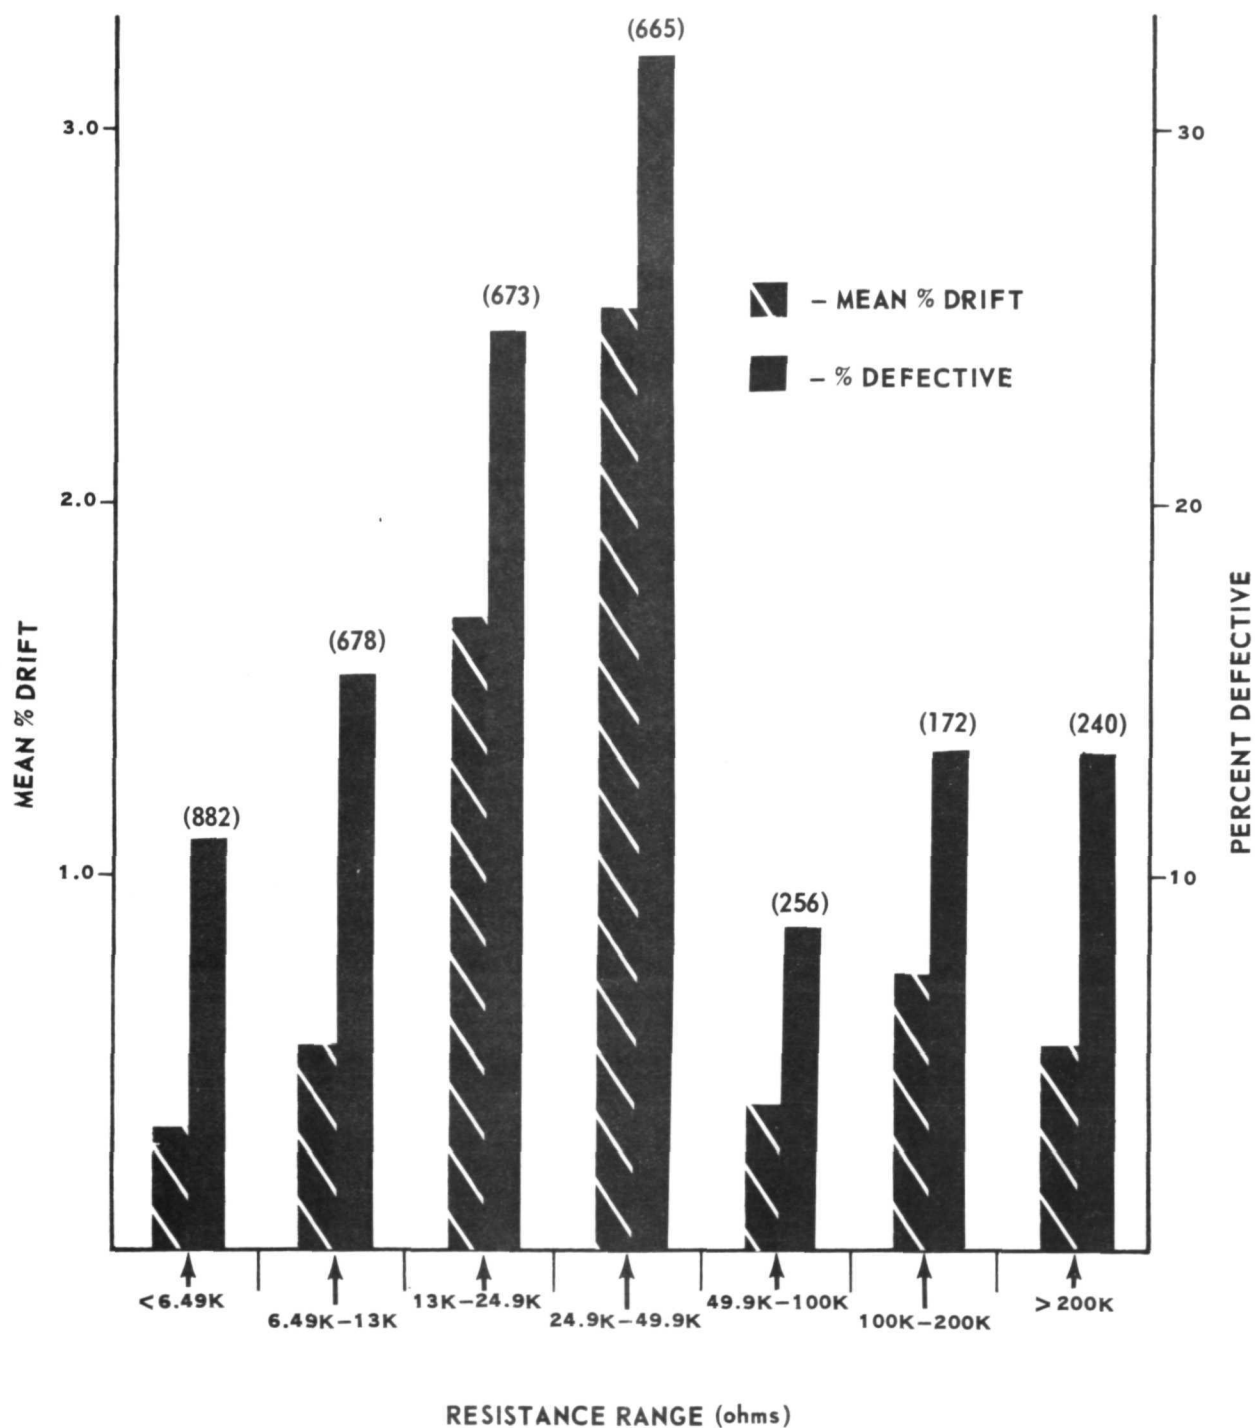
Figure 20. Population % Drift and % Defective Versus Resistance Range (Under All Test Conditions)

(1) Resistance Range. The resistors were divided into seven distinct resistance ranges. Each resistance range was not necessarily included in each test cell, but was selected such that each range had the same chance of being selected. When the data was analyzed the bar chart shown in figure 20 resulted. The analysis was independent of the voltage or temperature seen by the resistance ranges. As shown (all things being equal) the resistance range from 24.9K to 49.9K has demonstrated a higher percentage of defective resistors and a greater percentage of mean drift than the other resistance ranges tested; however, it is more important to note that no resistance range is free from defects. In addition, further analysis has also shown that no resistance value is free from defects.

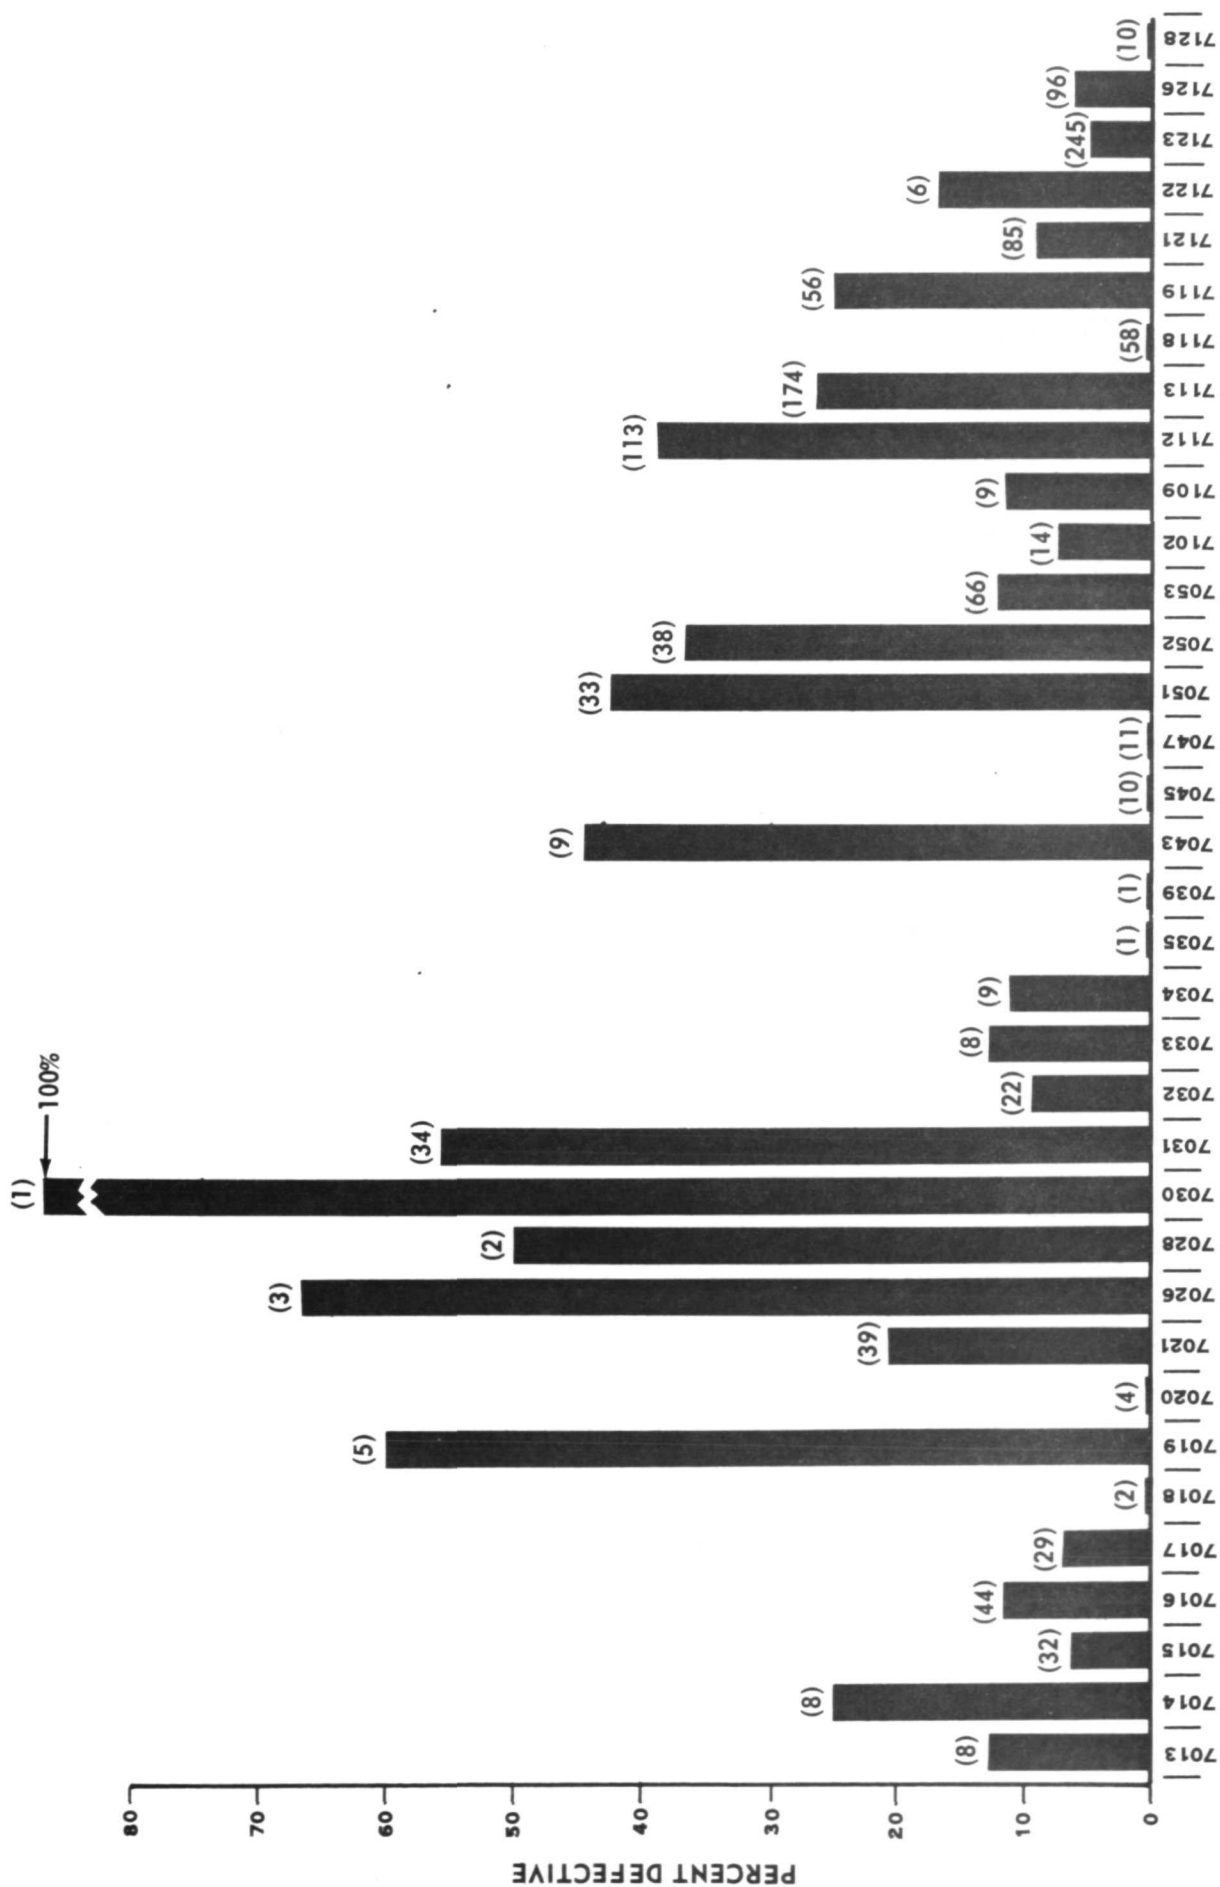
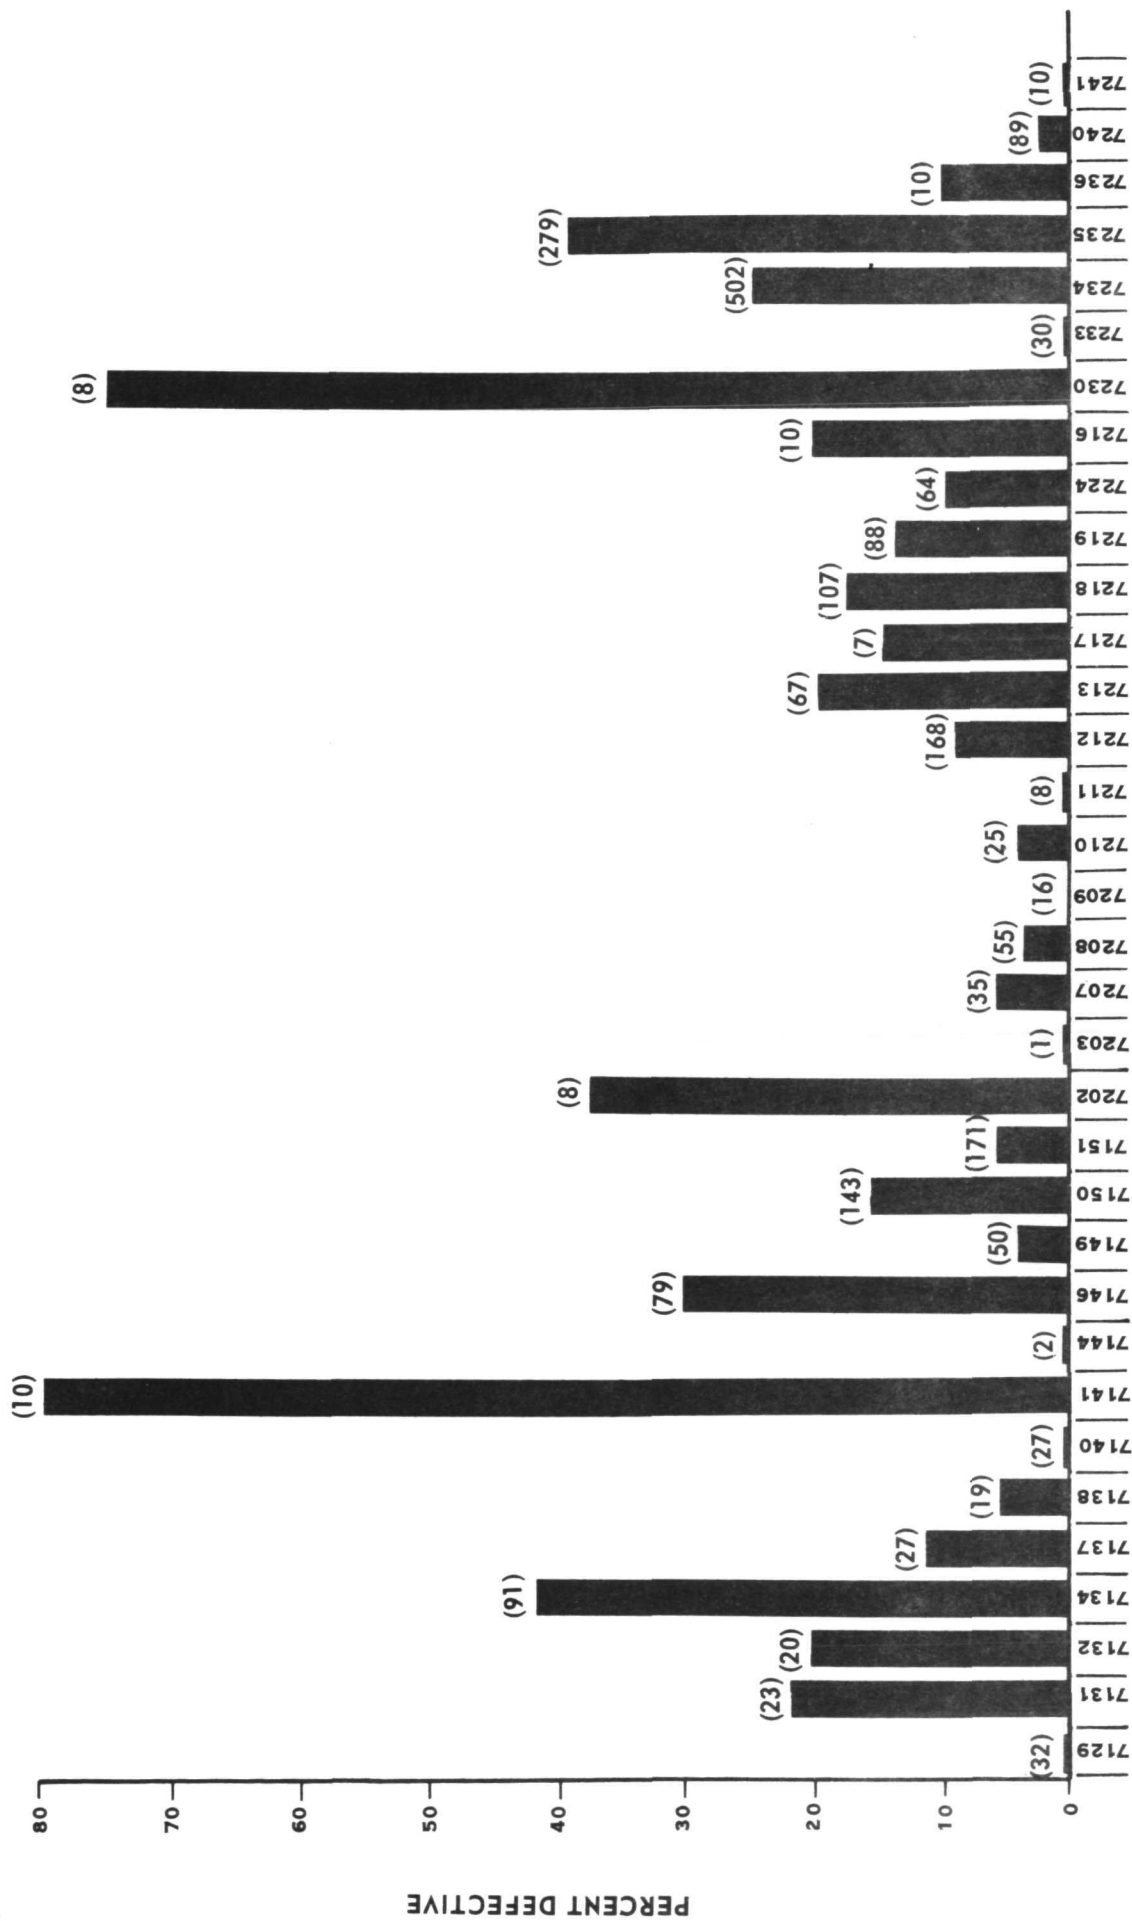
Figure 21. Percent Defective Versus Date Codes (Sheet 1 of 2)

(2) Date Code. The data collected on date codes tested were analyzed statistically using several techniques, such as weighting, normalization, etc.. None of these analyses produced a statistically satisfying correlation between drift and certain date codes. At first glance (figure 21) it would seem that date codes 7234 and 7235 have significantly more defects per total tested than the other date codes. A thorough search of data revealed, however, that these date codes were, for the most part, tested under what has since been determined to be worst case conditions. Therefore, it is concluded that the failure mechanism is independent of date code.

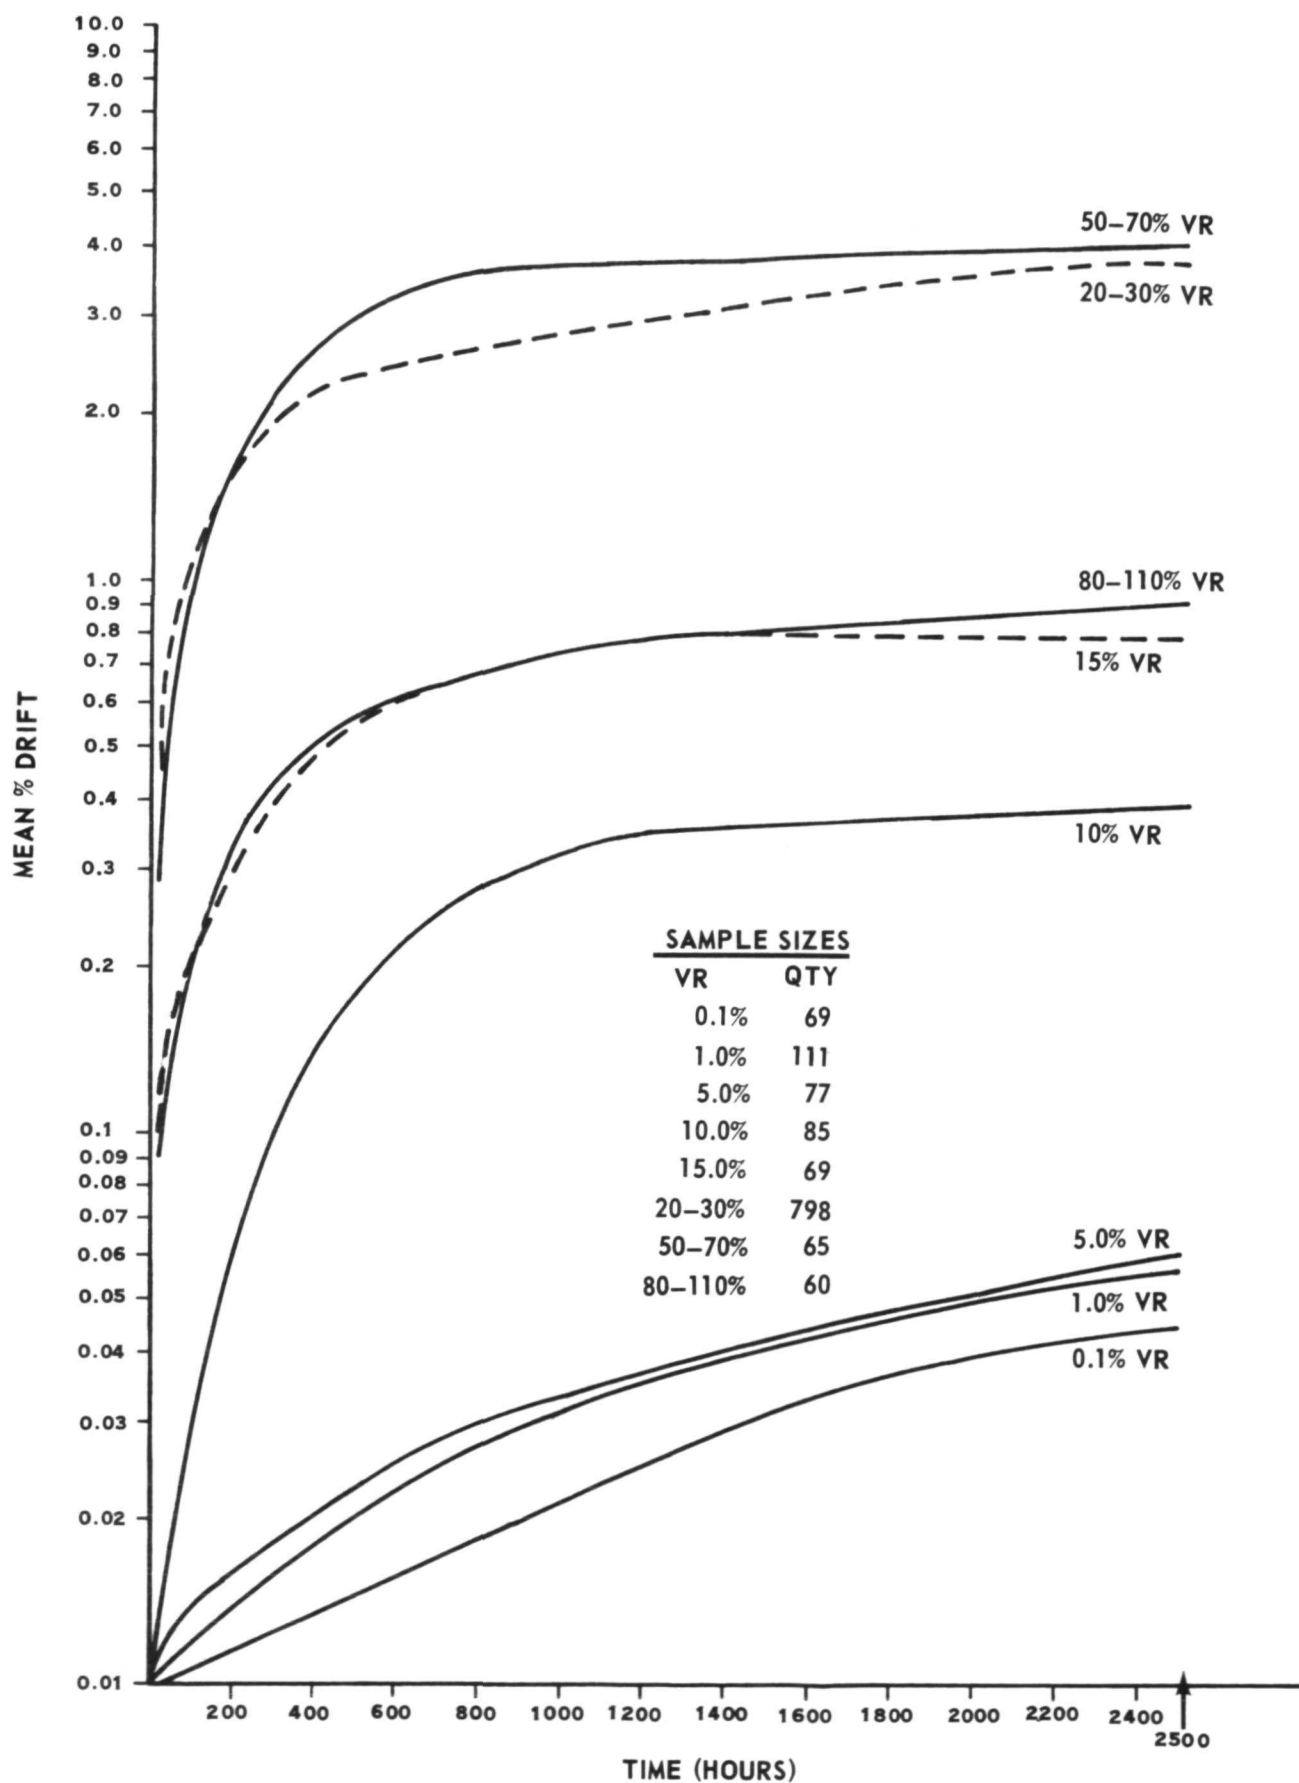
Figure 22. Applied Voltage Parameters, Mean % Drift Versus Time at 25 Degrees C.

(3) Applied Voltage. It was determined during testing, prior to the nondestructive stress tests conducted by MSFC, that the failure mechanism was exhibited when low level dc voltages (20 to 30 percent VR) were applied. Therefore, personnel at MSFC performed stress tests with this level of voltage and its surrounding values. The resulting data was analyzed in several ways. Two of these produced statistically satisfying correlations. Figure 22 shows that when the effect of the applied voltages is analyzed, at the worst case temperature conditions, the result is basically the same as when analyzed at all temperatures (see table 22). Based on these two analyses it can be stated that the drift is affected significantly more by applied voltages of 10 to 110 percent VR than 0.1 to 10 percent VR.

(5) Stabilization and Identification of Drifters. The results of the data analysis conducted on stabilization of the drift rate of the resistors are shown in figures 22 and 23. These figures show that the drift rate definitely decreases at approximately 400 hours. Although these curves include both resistors that haven't crossed the 0.2 percent defect threshold and those that have, they proved to adequately represent the behavior of the defectives and gross drifters. This was proven by analyzing the drift rates of all resistors that drifted more than 0.2 percent, resistors that drifted more than 10 percent but not more than 20 percent, and of these drifting more than 20 percent. These analyses all attested to the stabilization of drift at approximately 400 hours.

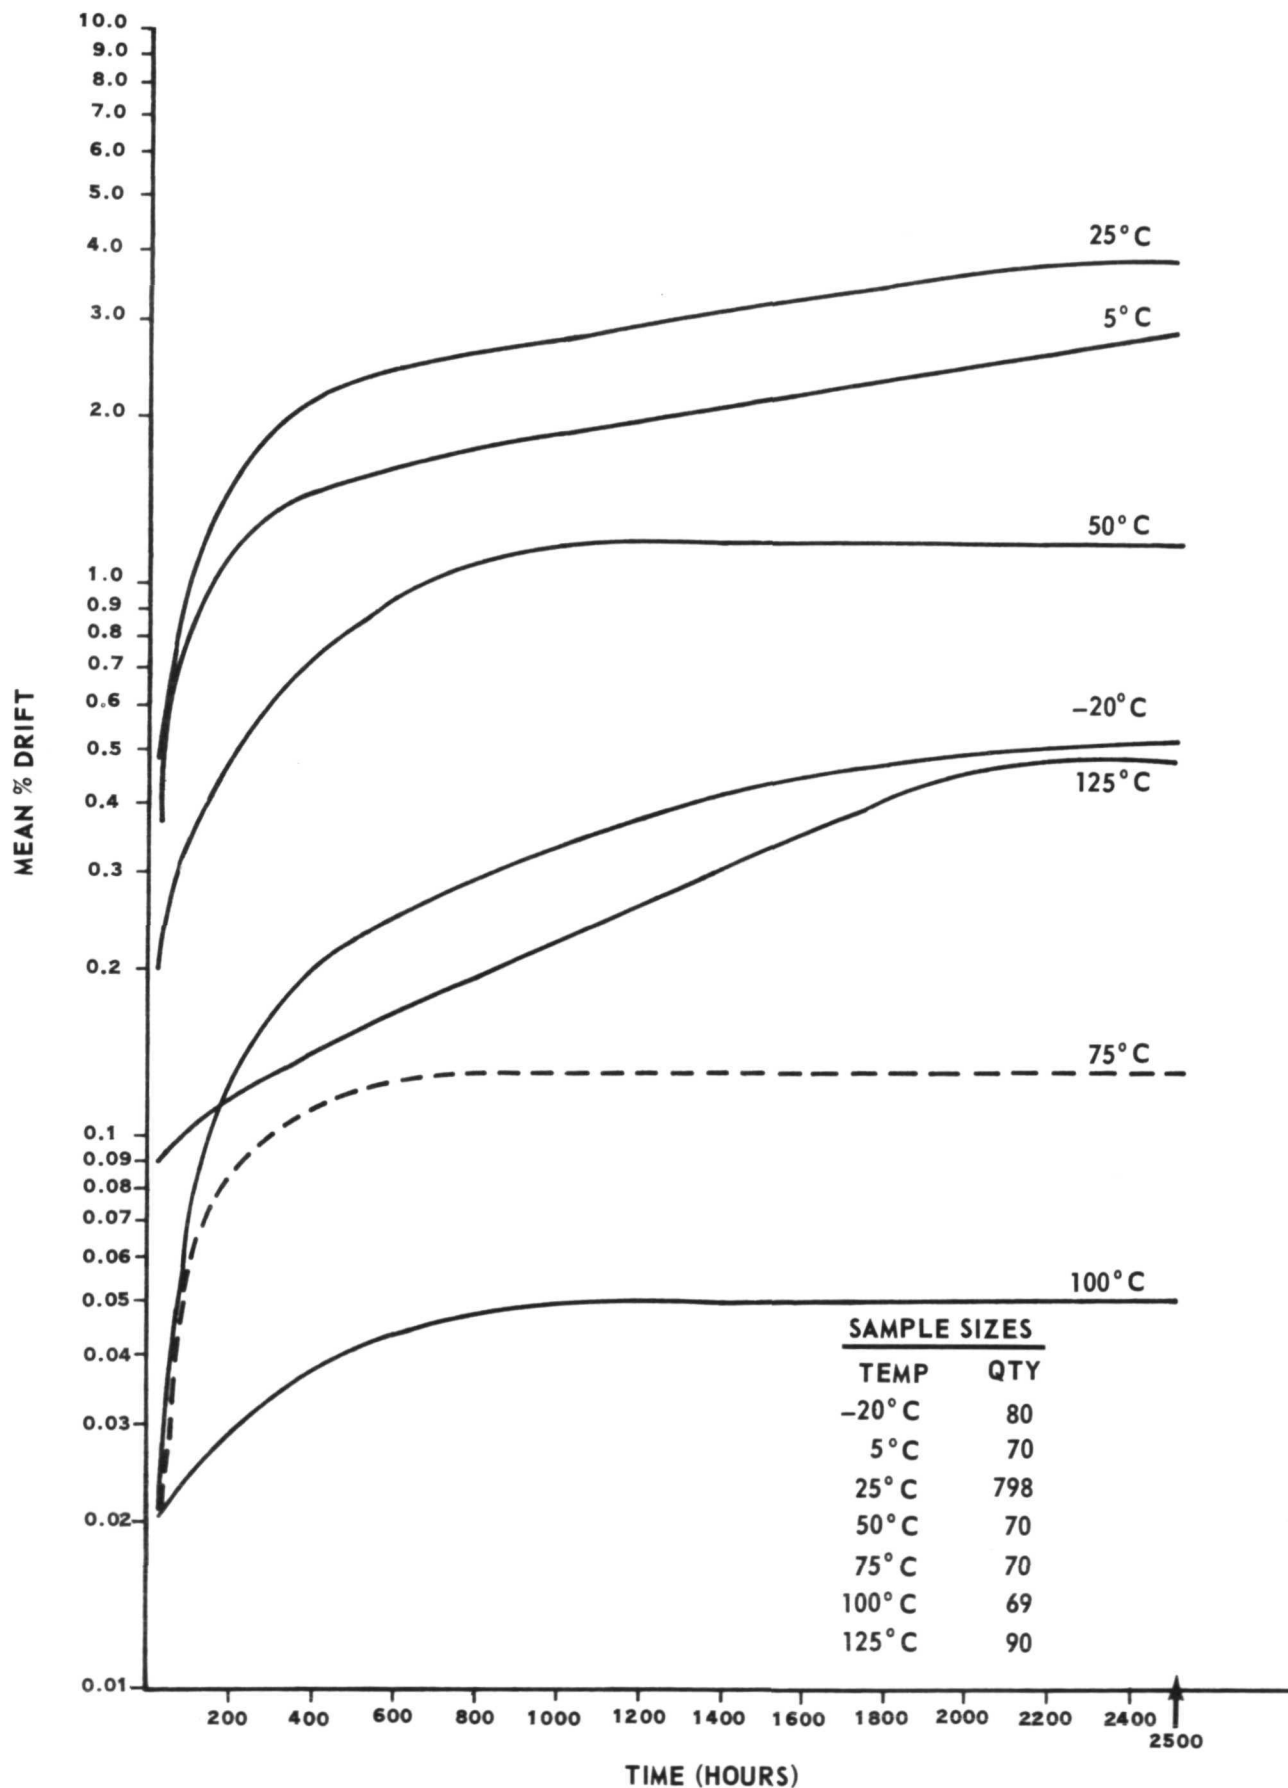
Figure 23. Temperature Parameters, Mean % Drift Versus Time at 20 to 30% VR

(4) Temperature. Data was analyzed for statistical conclusions concerning temperature using similar techniques as for the applied voltage discussed in e.(3) above. The two methods that produced statistical correlations are presented in table 23 and figure 23. Based on these two analyses it can be stated that the drift is significantly more affected by 5 and 25 degrees C than by the other temperatures tested. When data was correlated, temperatures of minus 25 and plus 50 degrees C showed a tendency to have more of an effect than temperatures of 75, 100, and 125 degrees C. Further testing can better define this separation.

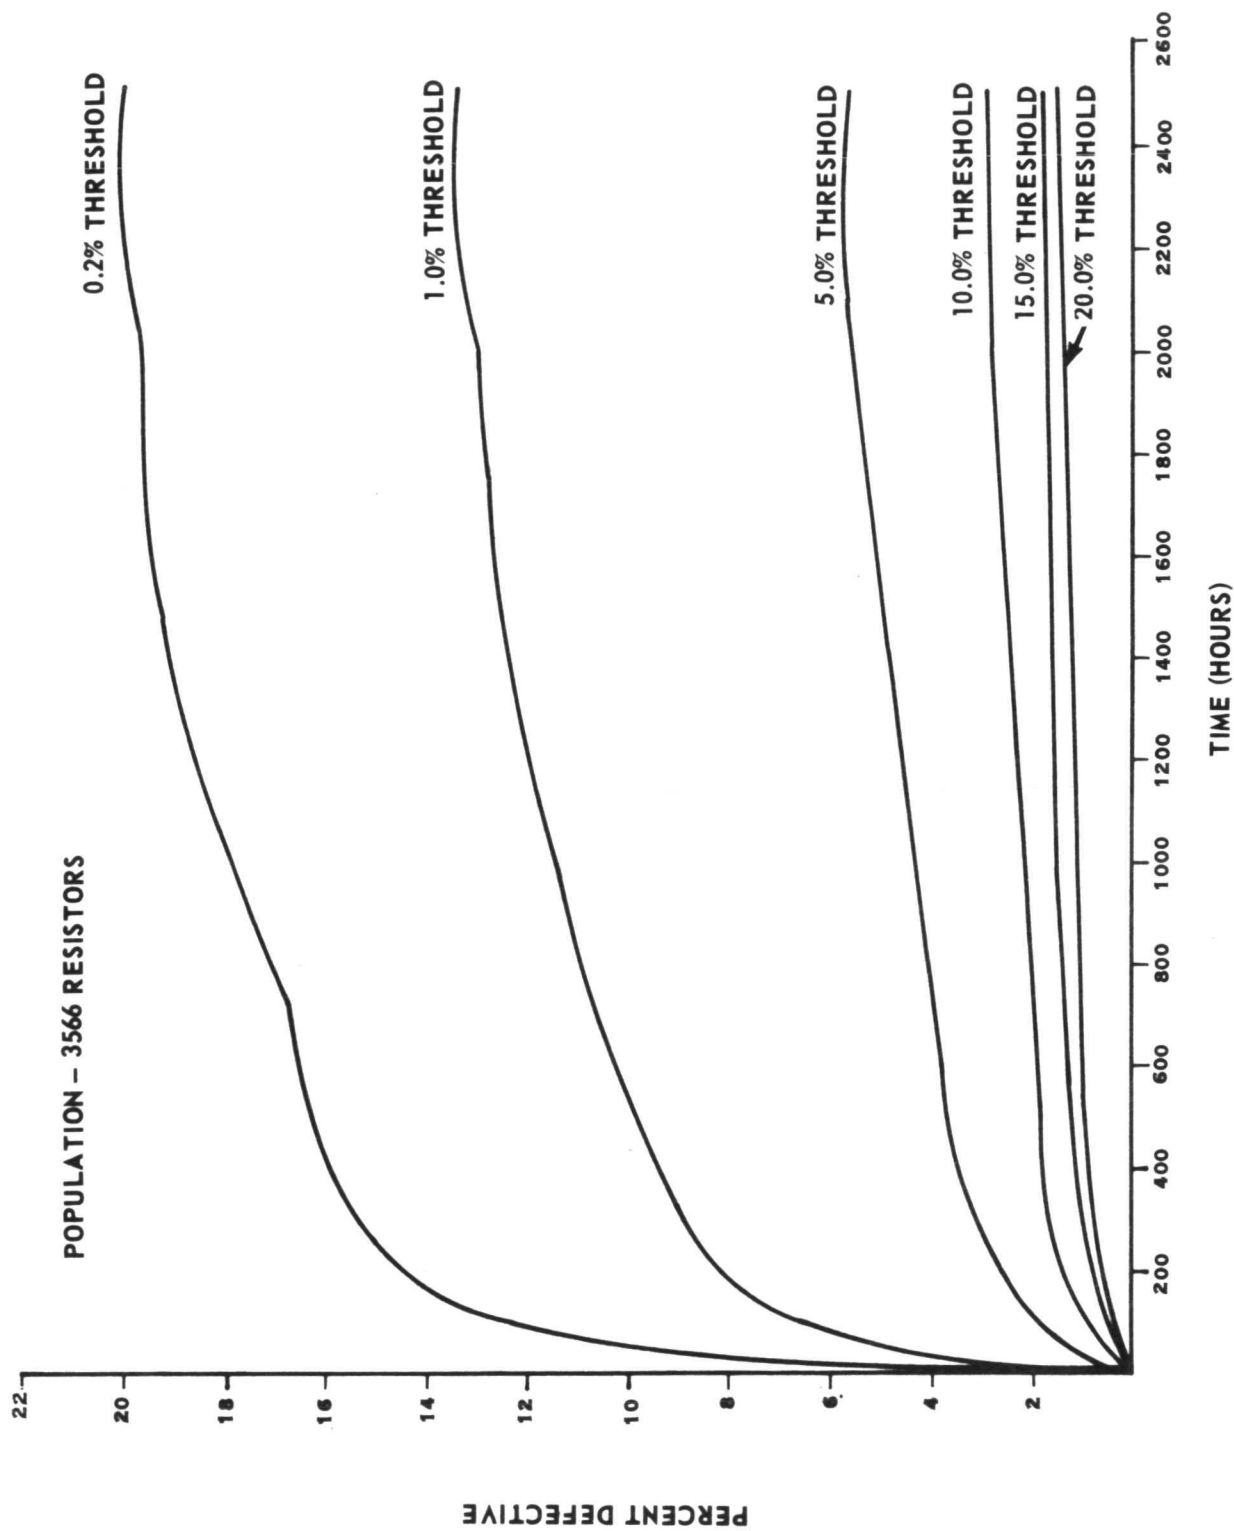
Figure 24. Cumulative Percent Population Crossing Defective Thresholds

Further analysis of data also showed that the greater percentage of resistors drifting more than 0.2 percent could be identified or seen prior to 200 hours. This analysis was later extended to encompass other defective thresholds (see figure 24). This was conclusive in showing that the drifters could be identified at 200 hours or less, depending on the threshold setting.

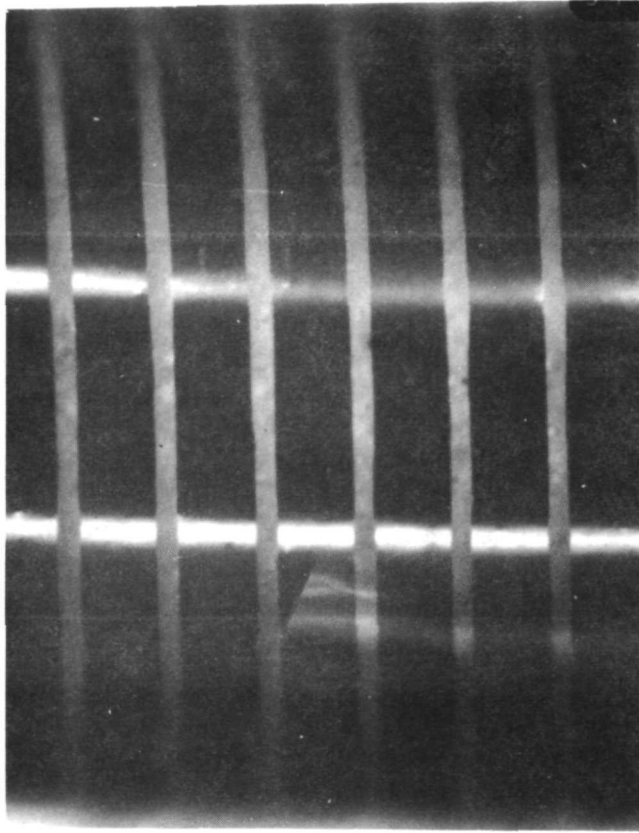
Figure 2. Stability of Nichrome in Good Resistor

These observations are all explainable by electrochemical dissolution of the nichrome, leading to decreased cross-section areas and higher

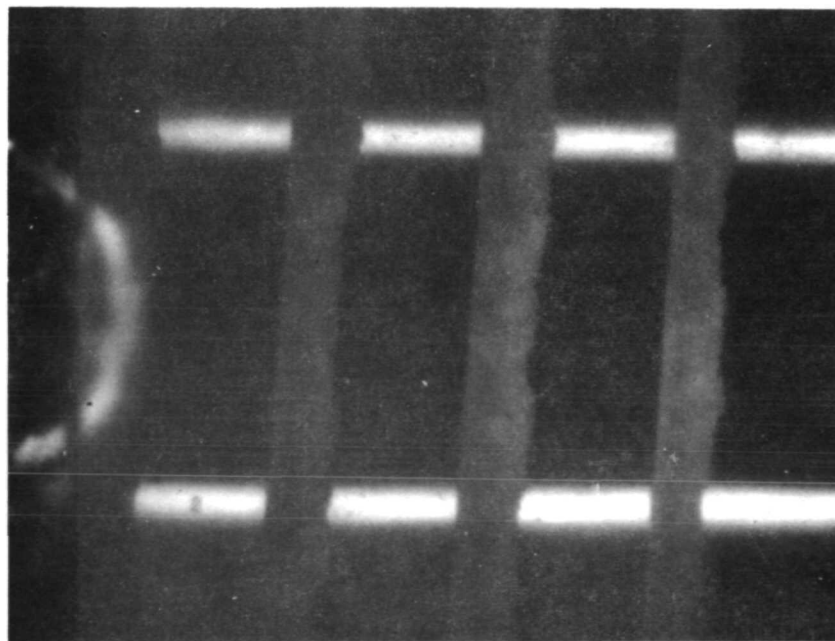
Figure 3. Removal of Nichrome in Bad Resistor

resistance values or drift. This premise formed the basis for the detailed drift mechanism study outlined in the following sections.

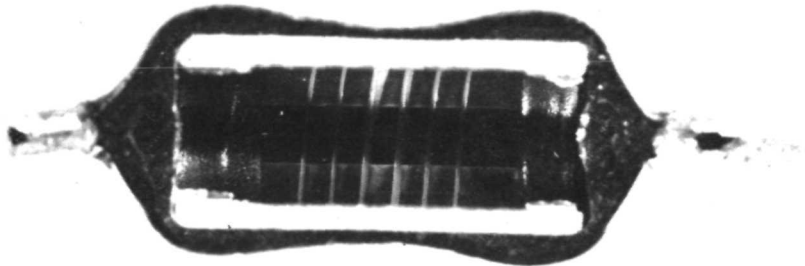
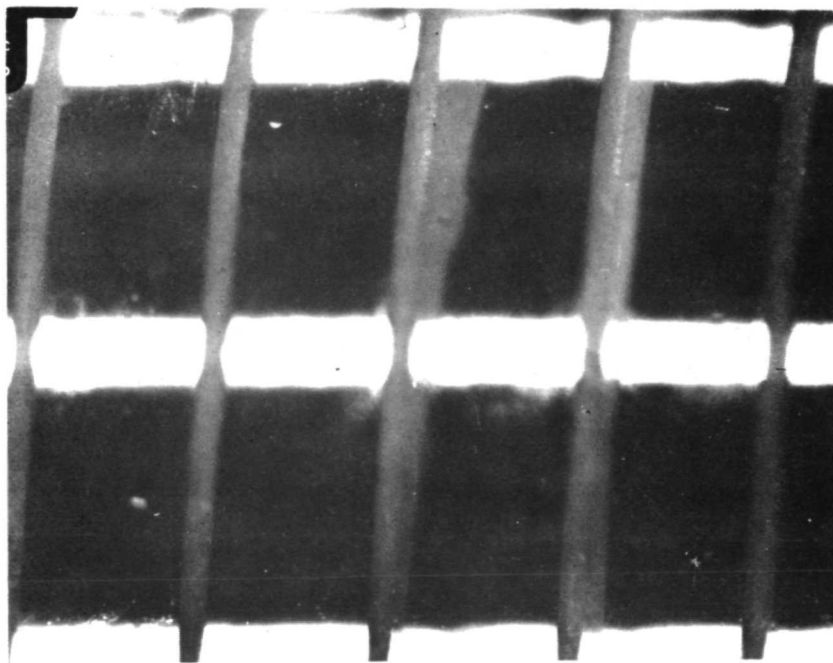
Figure 5. Drifting RNR 55C Vamistor Resistor

The nichrome disappearance in the bad resistors followed several patterns. In most of the resistors examined, the turns of nichrome at each end of the helix were only slightly affected and the gross nichrome removal occurred at several of the inner turns. The resistor shown in figure 5 is typical of this effect. This is an RNR55C 1/10-watt, 19,100 ohm resistor which was removed from an ATM flight PC board (P/N 50M12745-9) after drifting 9.2 percent in resistance value. Only the two center cuts are involved in the nichrome removal. Even in the case where the resistor goes electrically open (figure 6) the end turns are not significantly involved. This is an RNR55C, 1/10-watt, 49,900 ohm resistor, date code 7234, which opened in the QUAL Laboratory test matrix after approximately 800 hours at room temperature and 25 percent VR.

NOTE: The horizontal white bands are light reflections from the curved surface and should be ignored.

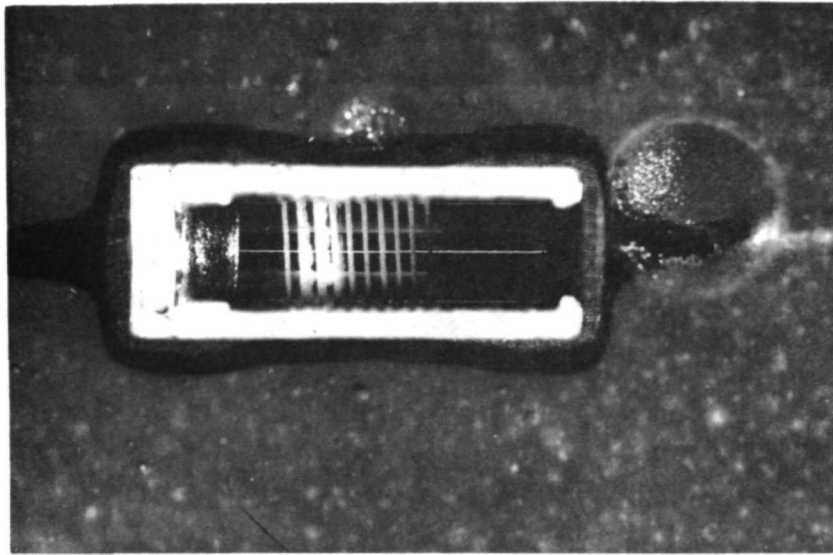
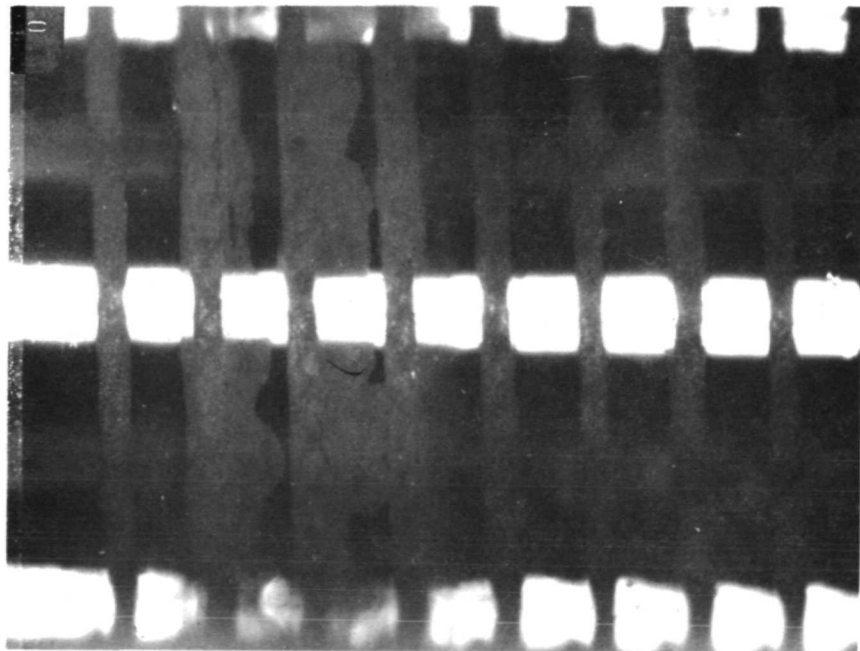
Figure 6. Open RNR 55C Vamistor Resistor

The complete removal of nichrome across one band, between cuts three and four from the right (figure 6), resulted in an electrical open in the resistor.

NOTE: The horizontal white bands are light reflections from the curved surface and should be ignored.

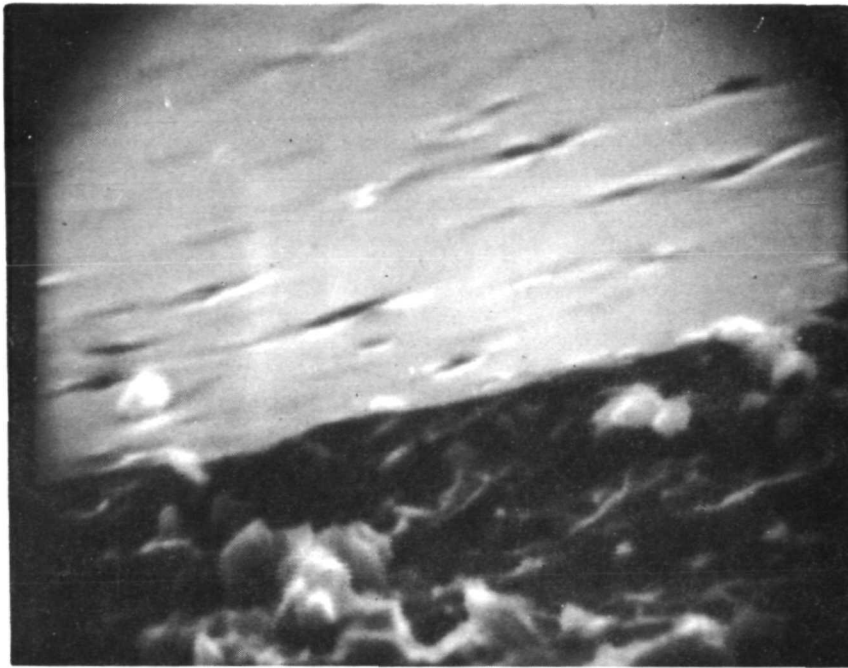
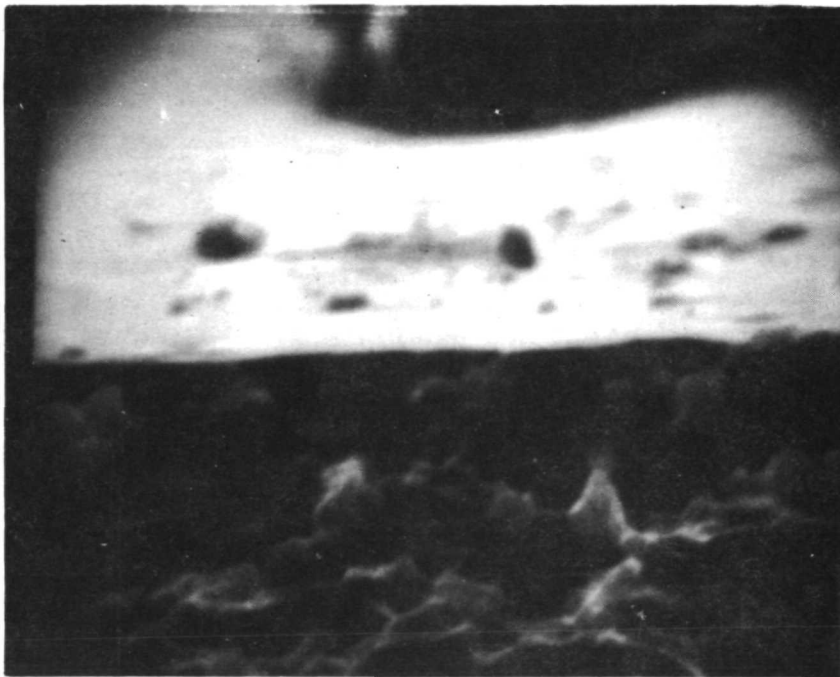
Figure 9. SEM Photomicrograph of Nicrome Cut

which makes the helical cut is disrupting the nichrome glass/bond, the plating solution may penetrate to this extent and aggravate the nichrome dissolution process. It was shown, however, that this was an unlikely event by the use of SEM photomicrographs of the edge of the cut where the nichrome glass interface begins. Figure 8 illustrates the angle of observation of the cut and figure 9 show the smooth edge of the cut, from two different resistors (even at 10,000 X magnification), indicating no irregularities that might be consistent with damage to the nichrome/glass bond.

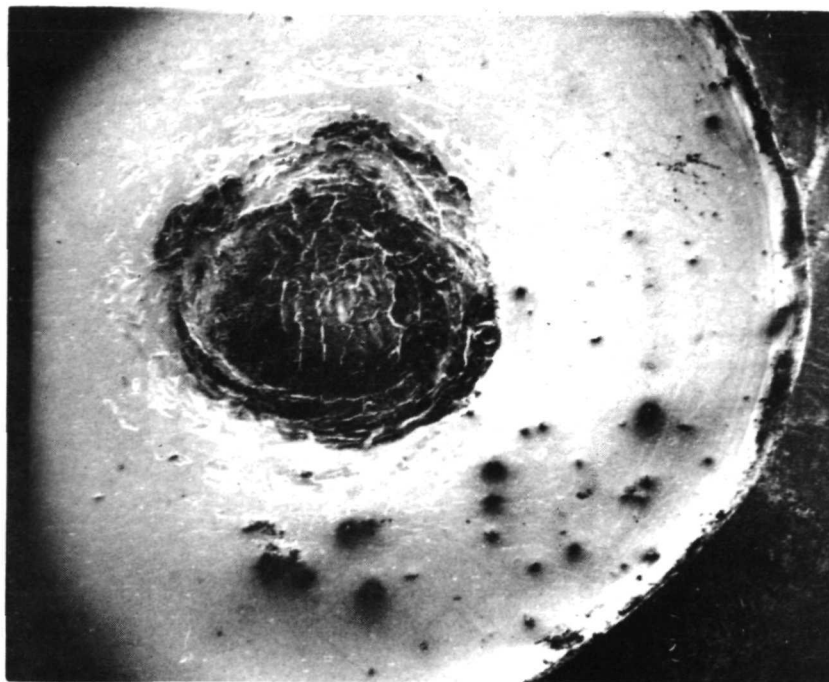
Figure 10. Copper Salt Contamination on Resistor Endcap

At least two additional anomolous conditions were observed in drifting resistors as shown in figures 10 and 11. In figure 10, microprobe analysis indicated that the green crystalline deposit was a copper compound, but the sulfate anion was not detectable. In figure 11 microprobe analysis indicated an iron compound. The established pattern of nichrome removal was apparently not affected by these contaminants and it appears unrelated to the electrochemical phenomena; however, the presence of the extraneous materials in figure 10, 11, and 12 expand the concern over the vendor's inadequate contamination control requirements at the time of manufacture.

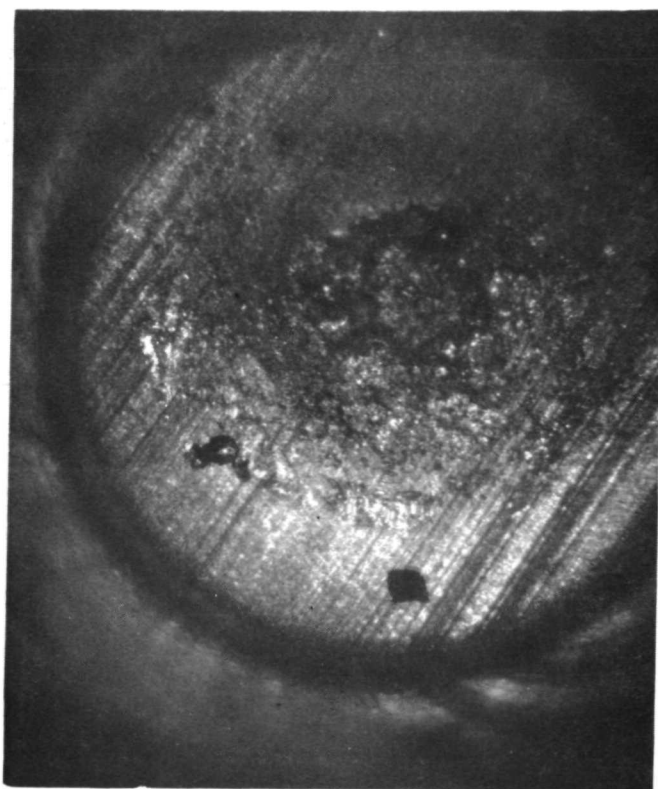
Figure 12. Copper Deposit on Resistor Endcap

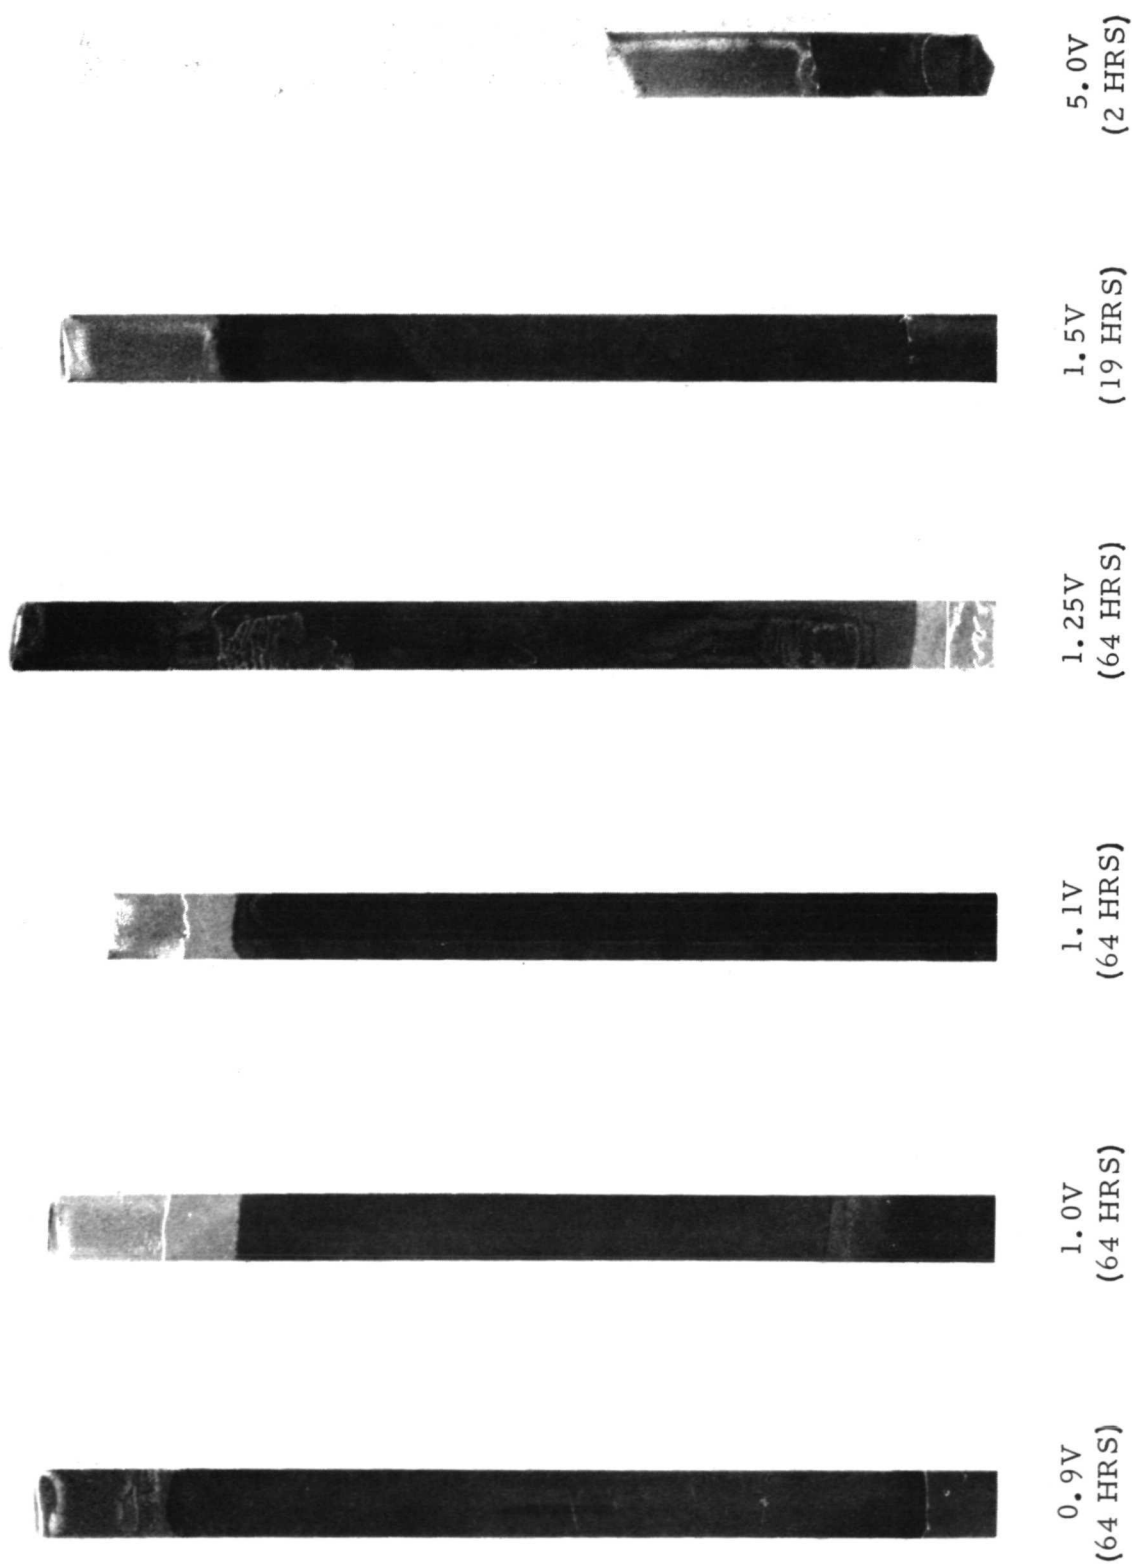
Figure 14. Anode Dissolution As A Function Of Cell Voltage

Initially, tests were conducted to determine time, voltage, and plating solution concentrations necessary to effect anodic dissolution observed in the actual resistors. Voltages from 0.9 to 5.0 vdc were utilized, with a concentration of plating solution of 5.0 percent by volume, based on the original concentration of solution supplied by Vamistor personnel. The exposed area of the nichrome electrodes was 5.1 cm^2 , with a spacing of 2.54 cm. Figures 14 and 15 are shown for comparison of the electrolytic effects on anode and cathode through this voltage range. In figure 14 there is a very minor effect on the anode after 64 hours at 0.9 vdc. The effect is progressive with increasing voltage and is reasonably linear with time up to approximately 1.5 vdc. At higher voltages the anode dissolution is much

The onset of significant electrolytic activity in the area of 1.5 volts, as shown by the condition of the electrodes (figure 14 and 15), is considered quite significant and a series of current/voltage experiments were carried out to study the observation. Current versus voltage data were collected
